# Sanitary Sewer Asset Management Plan

EGLE Project No.1681-01

## **VILLAGE OF PINCKNEY**

WOLVERINE ENGINEERS & SURVEYORS, INC. | 312 North Street, Mason, MI 48854

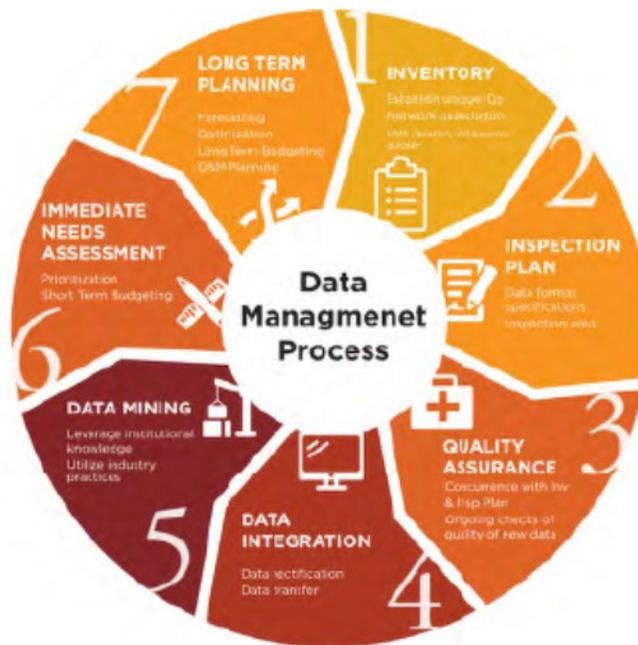
Figure 12.1: Data Management Process Diagram
