Effects of Tree Canopy on Rural Highway Pavement Condition, Safety, and Maintenance

The Ohio Department of
Transportation
Office of Statewide Planning and
Research.

February 2017

Final Report

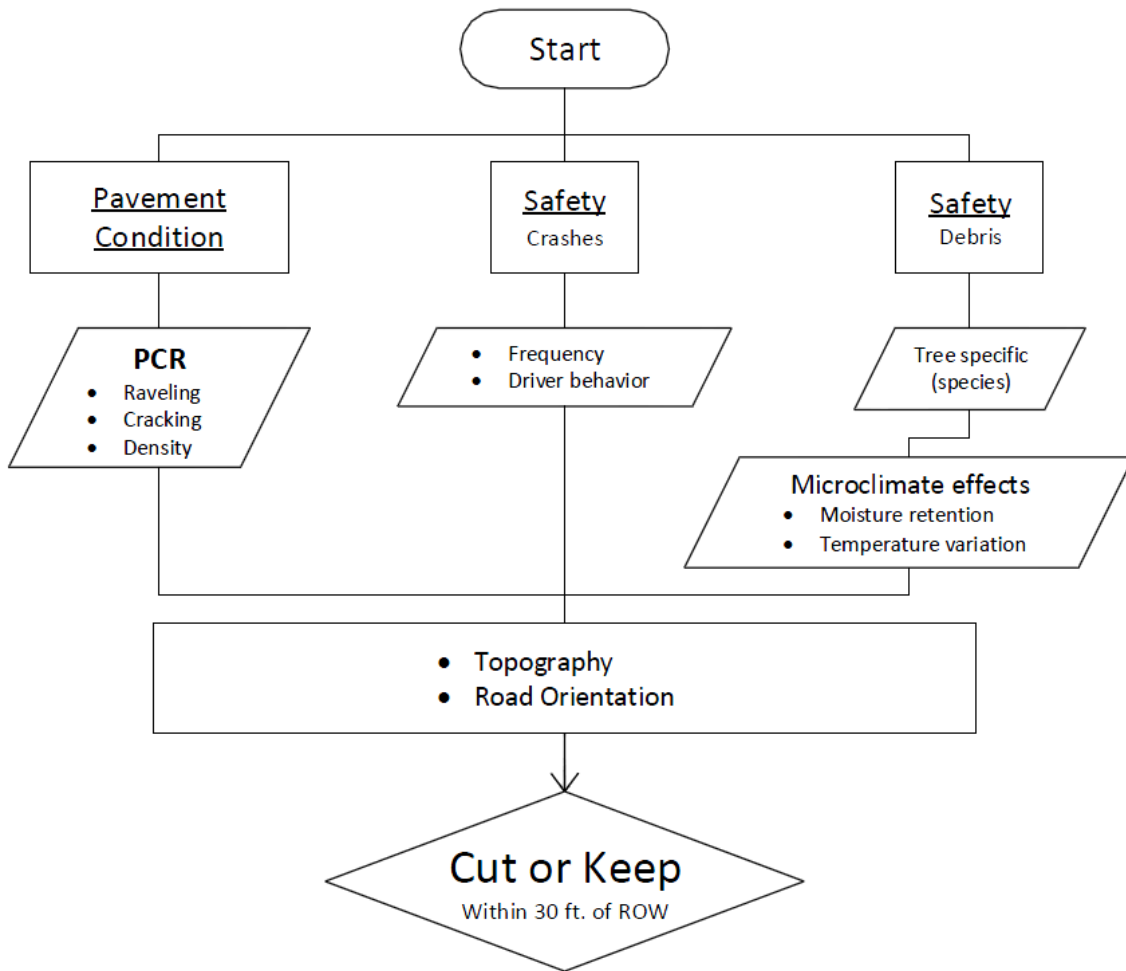
Figure 1. Decision Making Process for Tree Canopy Maintenance.

Based on the findings of this research project, it is recommended that the Ohio Department of Transportation (ODOT) develop a decision making tool or process that will assist ODOT Districts with their tree canopy maintenance. This decision making tool should be based on focused research to assess the impact of trees and tree species on pavement degradation, road condition, and road safety in climatic conditions typical of Ohio. Such a tool would bear a resemblance to Figure 1.

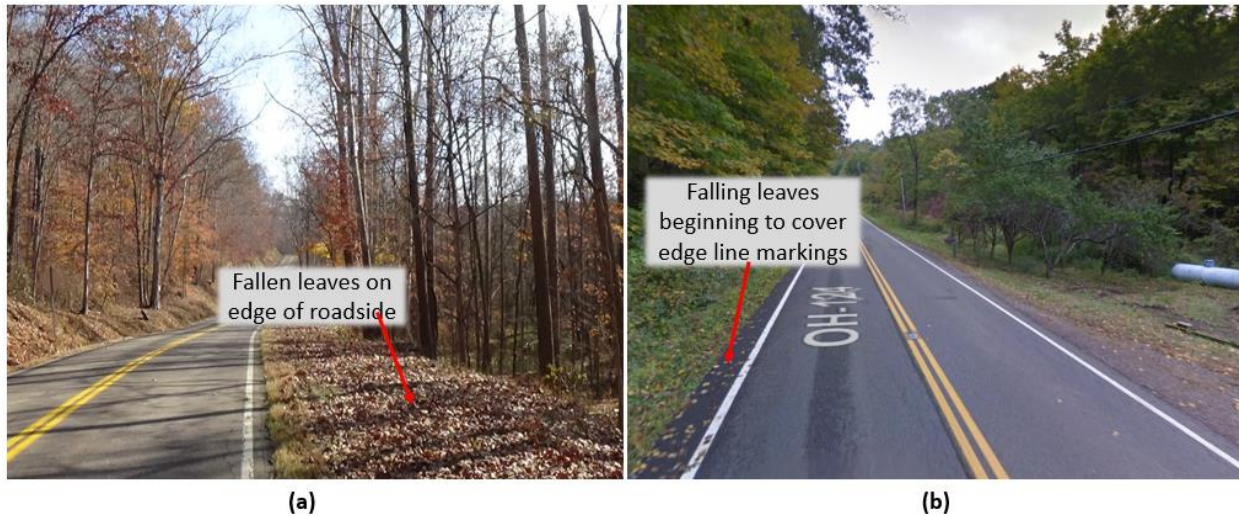
Figure 6. Effect of Fallen Leaves on Roadside.

During the fall season, leaves from trees alongside the roadway had fallen off as seen in Figure 6(a) on OH-356. These fallen leaves, depending on roadside edge (slope/no-slope or shoulder size), have the potential of covering the edge lines (see Figure 6(b) on OH-124) of the roadway and this can become a safety concern especially during foggy, and wintery snow conditions when drivers have a reduced vision and use line markings to maintain their position on within the travelled lane. Also, the fallen leaves store moisture within their layers which could potentially freeze during the evenings (when temperatures drop during the winter) and form a layer of ice. This mix of leaves (coated with ice) can potentially be a safety concern for drivers

who are unaware of the presence of the slick surface. Additionally, there can potentially be concerns of the fallen leaves blocking ditches, culverts and drop inlets.

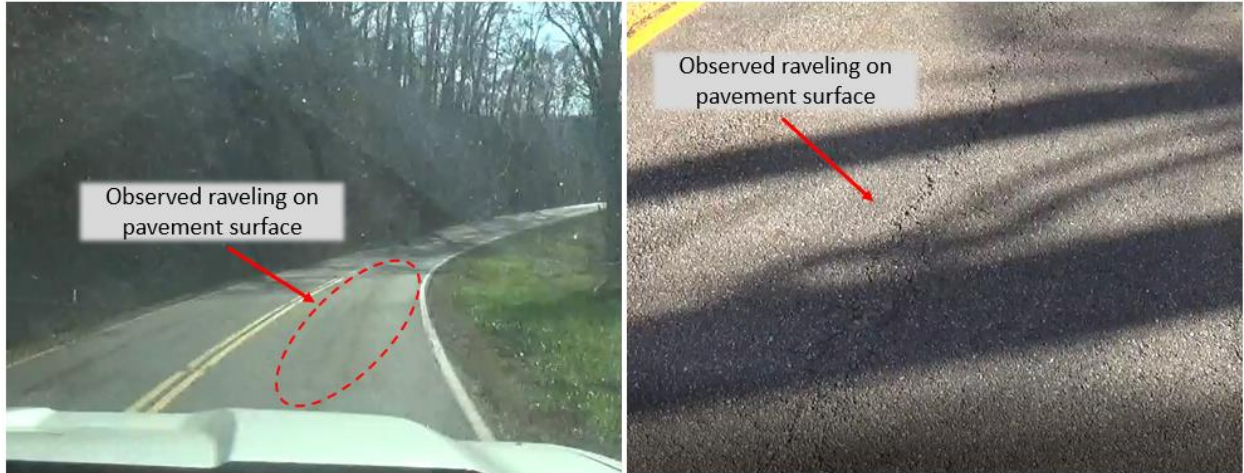
Figure 7. Raveling on Canopy Covered Pavement Sections.

On the canopy section of roadway, there was noticeable amounts of raveling occurring on the pavement surface as shown in Figure 7. The observed stripping of aggregate particles and cracking is partially due to the presence of moisture on the pavement surface. It is likely that moisture is present for long periods due to a lack of exposure of the pavement to direct sunlight. It was also observed that within the canopy shaded sections, there were a number of locations that were patched (see Figure 8) due to localized raveling as opposed to unshaded sections that had no patching.

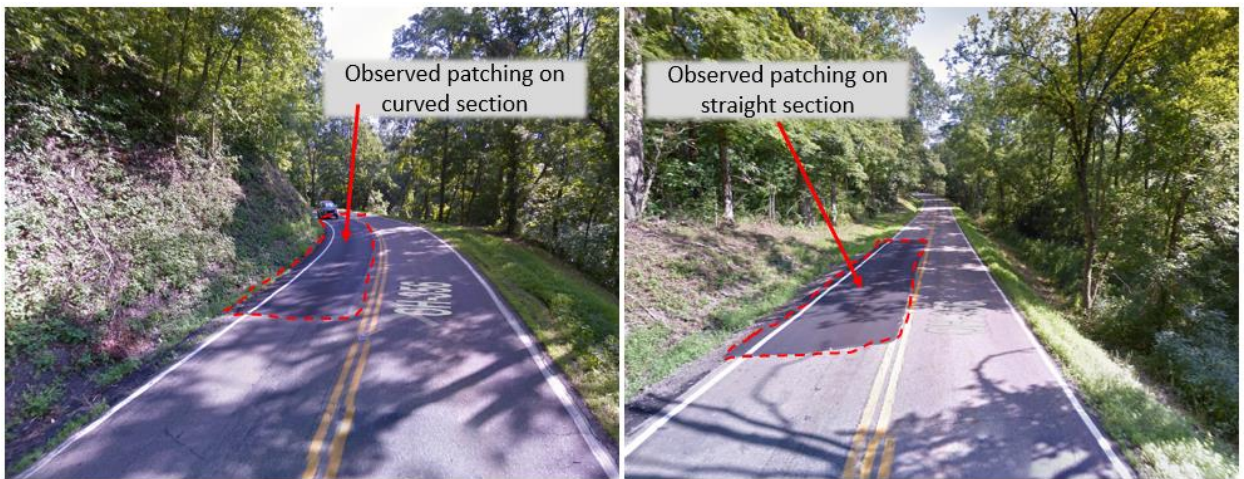
Figure 8. Patched Pavement Sections Under Canopy Cover.

Additionally, the curved sections of the roadway had relatively more patching than on the straight sections. On one hand, it is likely that the curved sections are prone to raveling faster than straight sections because there is an increased amount of traction and braking going on between the tires and pavement on the curved sections. On the other hand, and from a safety perspective, this is a concern because (i) during the winter, the moisture present on the pavement could potentially freeze and cause the pavement surface to become slippery, and (ii) there is a high potential of hydroplaning.

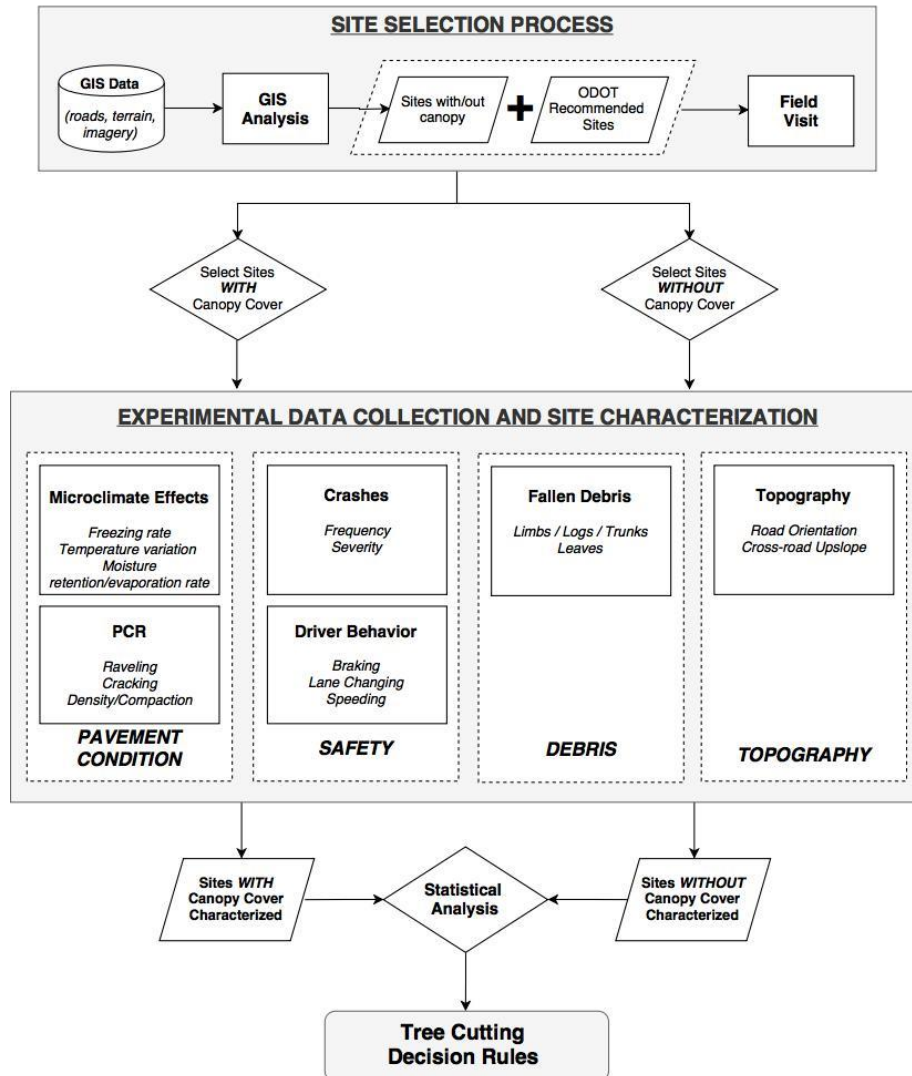
Figure 10. Proposed Study Design for Phase II.

On the recommendation of the technical panel, the Ohio University research team anticipate pursuing the recommendations that have been presented. The overall goal of phase II would be to provide ODOT with a better understanding of the effects of tree proximity on pavement integrity, drivable surface condition, and safety. The proposed design for the tree and pavement study to be adopted for phase II is depicted in Figure 10. Specifically, phase II will attempt to fill the gap in the body of knowledge on how trees influence pavement degradation and safety in a cool-temperate climatic region. Based on the findings from phase I, the research team propose to pursue the following testable predictions.
